Electrostatic discharges and their effect on the validity of registered values in intracranial pressure monitors

MORTEN ANDRESEN,¹ MARIANNE JUHLER¹ & OLE CORNELIUS THOMSEN²

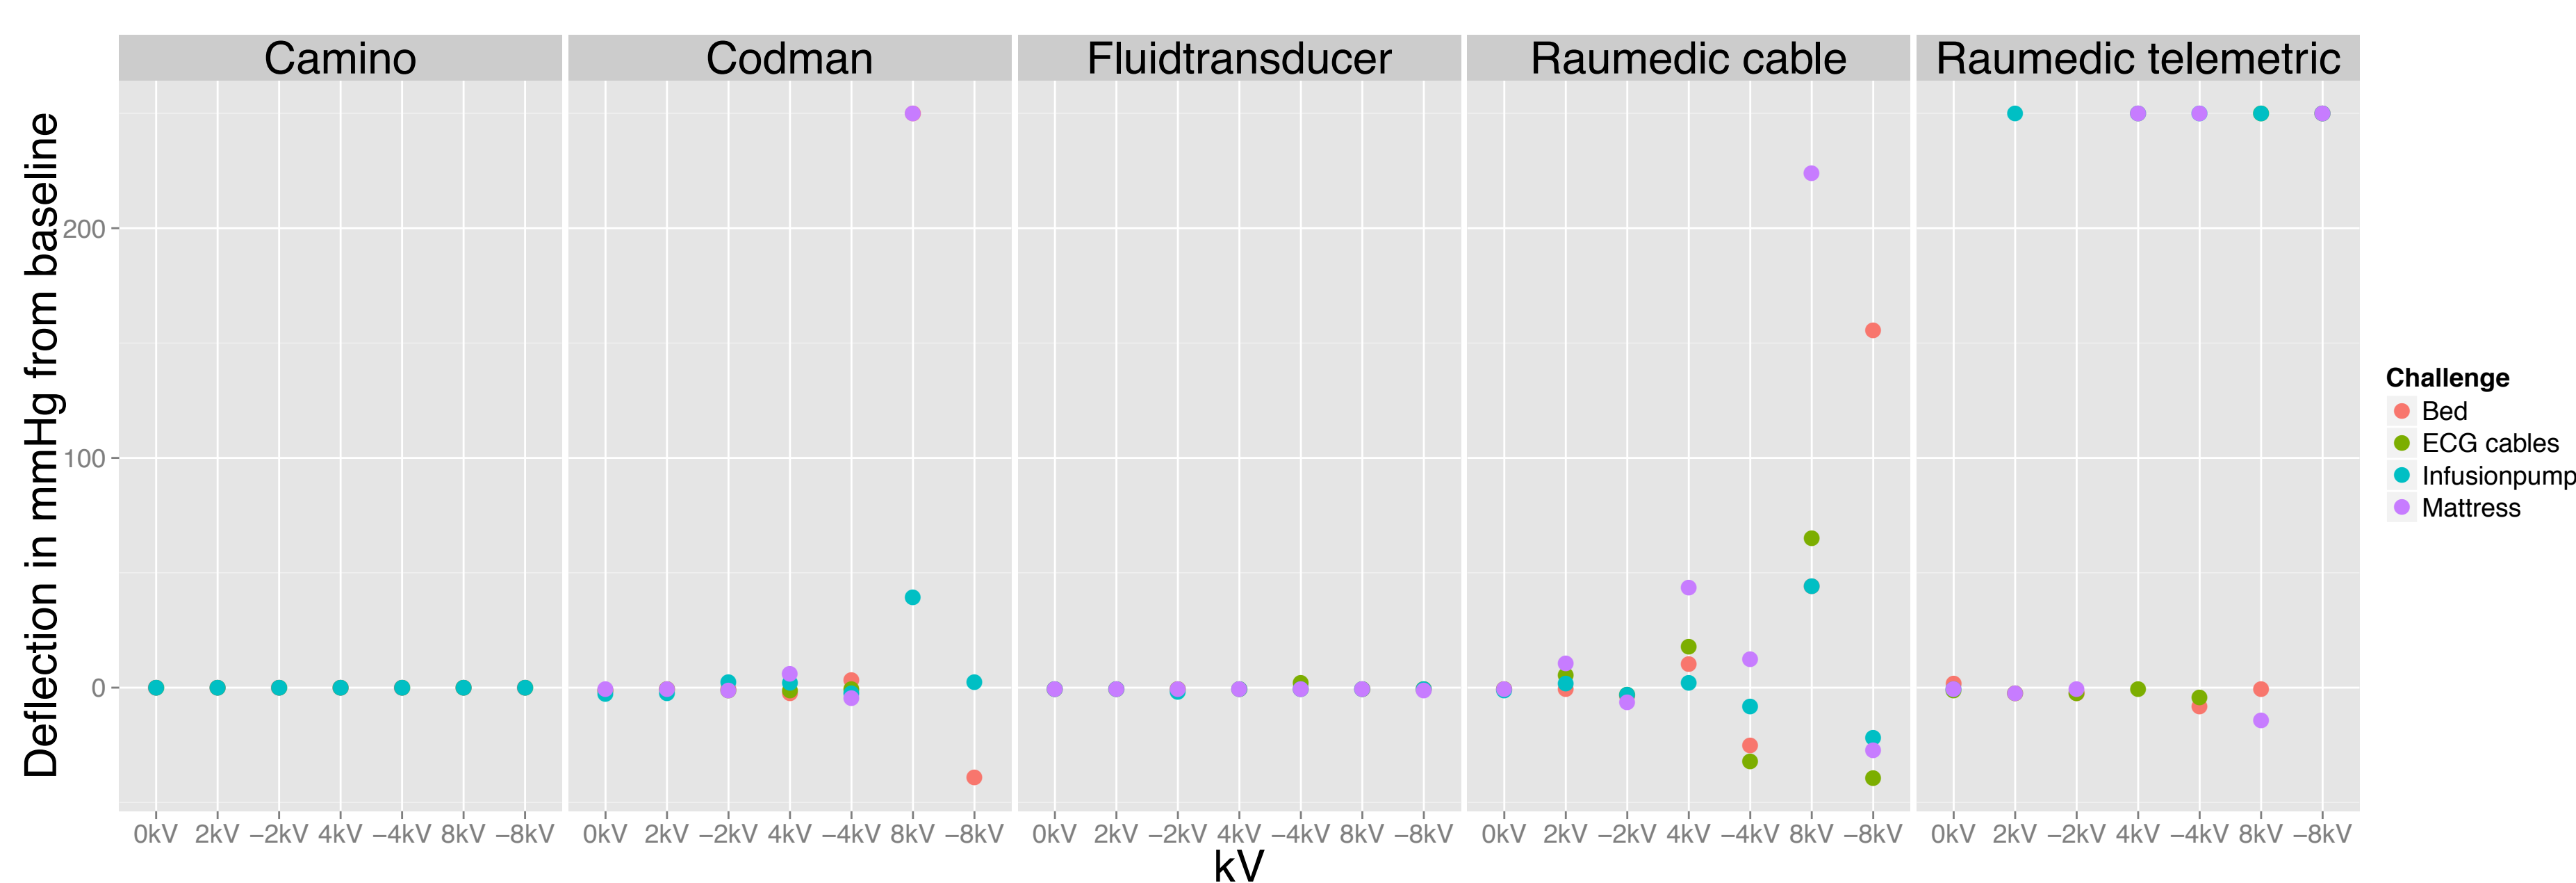
Figure 2. Maximum deflection of ICP in mmHg as a function of applied kV and 'challenge' levels. The fluid-filled transducer and the Camino monitor, were the only monitors not affected by electrostatic discharges. All monitors with electrical components at the tip of the transducer were affected by ESD. The polarity of the applied voltage affected the direction of the deflection. (A value of 250 mmHg is an error value indicating a lost signal.)

We evaluated five pressure monitors from four manufacturers. Three monitors containing electrical circuitry at the tip of the transducer were all affected by electrostatic discharges (See Figure 2).

The monitors had different levels of sensitivity to discharges at low voltages.

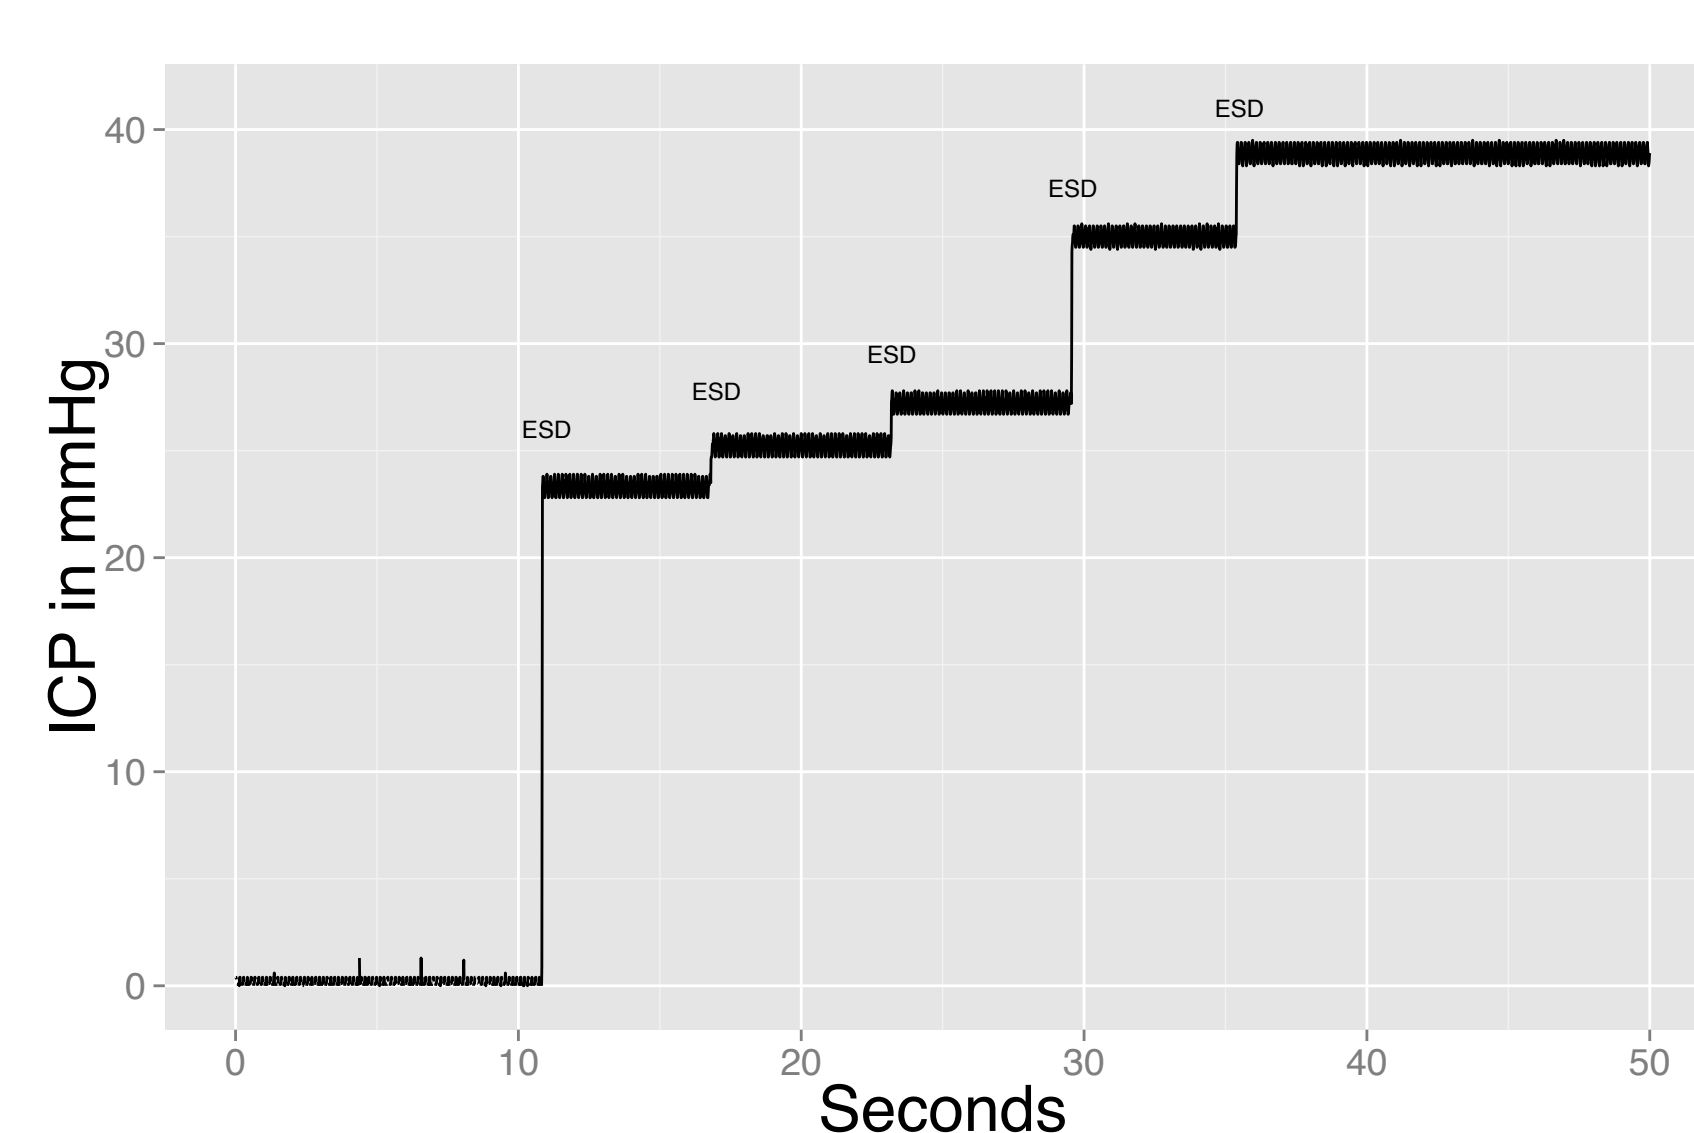
We saw clinically significant permanent changes in the reported ICP values for one pressure monitor (See Figure 3), and temporary deflections for two other monitors.

Figure 3. Permanent displacement of the ICP baseline in the Codman MicroSensor. On repeating the test, the sensor eventually permanently malfunctioned.

We recommend instituting policies for reducing the risk of subjecting patients to electrostatic discharges in the neurointensive care setting.
